Inspection Report

Property Address:
267 Engleburn Ave.
Peterborough

Paul Galvin Residential Home Inspections

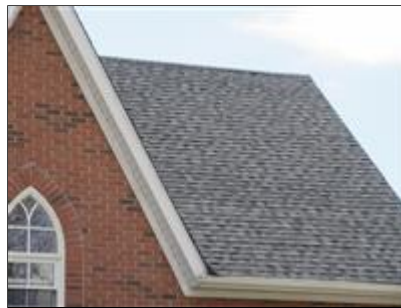
1.0 Picture 1

The entire roof surface is asphalt shingles. The shingles appear to be relatively new and are in good overall condition. They are installed well with all of the necessary caps and flashings.

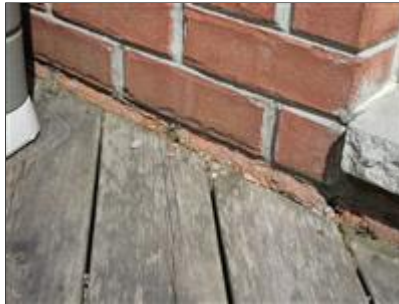
2.0 Picture 1

(2) There is some very slight moisture damage to the brick at the back of the garage where the deck is secured to the wall. This would be due to moisture being held against the brick. This is a minor concern. No immediate action is necessary. Someday if/ when the deck is replaced, the affected brick can be replaced.

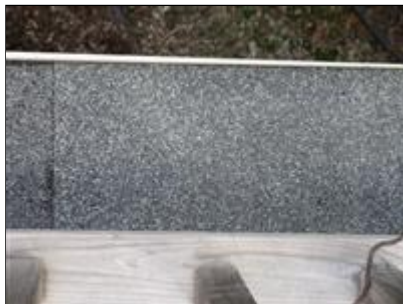
2.4 Picture 1

The balcony roof surface on the addition appears to be modified/ rolled asphalt with a rubber membrane on the garage roof. I cannot determine the exact condition of these surfaces as they are covered with wood decking.

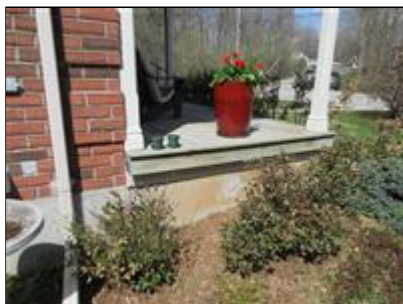
2.7 Picture 1

Ideally a railing/ guard should be installed on the front porch where more than two feet off the ground.

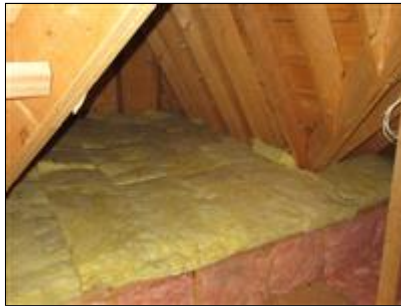
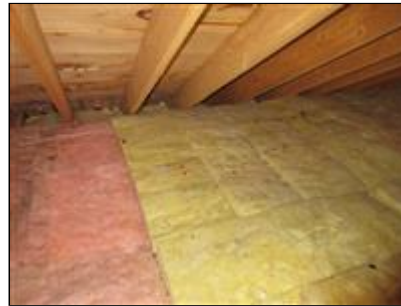
4.0 Picture 1

The attic contains fiberglass batt insulation. This insulation appears to be well placed and installed in adequate amounts.

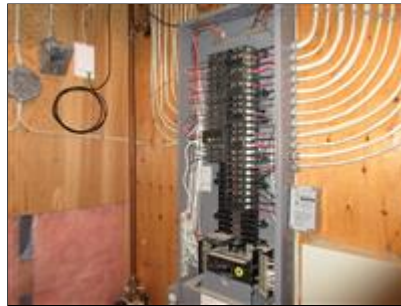
5.2 Picture 1

The main electrical panel was inspected and found to be installed properly and wired correctly. All of the proper sized breakers were present.

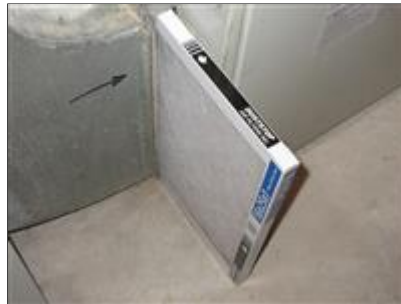
6.0 Picture 1

- (1) The furnace was tested and inspected and found to be installed properly and working well. All the necessary safety features were present.
- (2) The furnace filter should be changed on a regular basis.

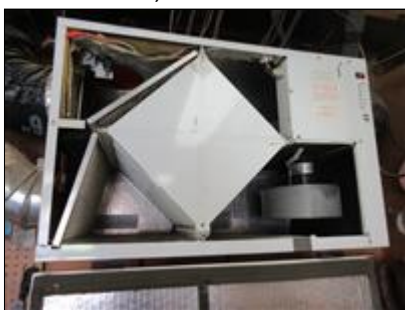
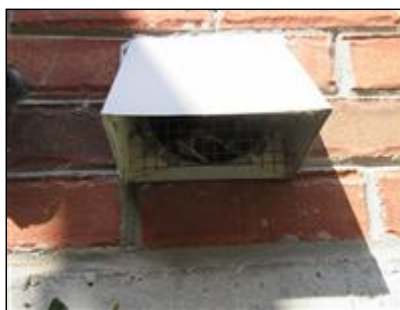
6.9 Picture 1

The heat recovery ventilator filters including the outside fresh air intake screen will require cleaning on a regular basis (see manufacturers recommendations).

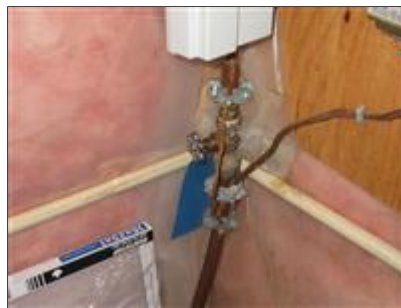
7.4 Picture 1

Front left corner of the basement.
