# Inspection Report

**Property Address:**  
210 Lonsberry Lane  
Warsaw

**Paul Galvin Residential Home Inspections**

<b>Date:</b> 2022-03-14	<b>Time:</b>	<b>Report ID:</b>
<b>Property:</b> 210 Lonsberry Lane Warsaw	<b>Customer:</b> Dave Tomlinson	<b>Real Estate Professional:</b> David Tomlinson Royal LePage

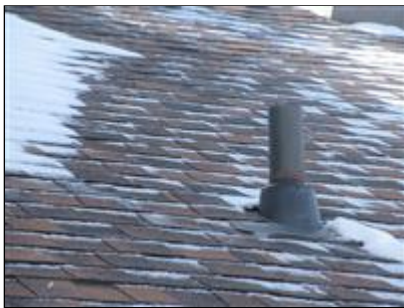
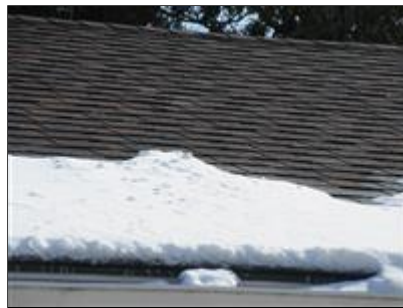
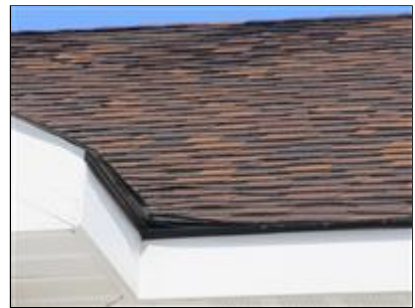
1.0 Picture 1

The entire roof surface is asphalt shingles. The shingles where visible, (partially snow covered) appear to be in good overall condition. They are installed well with all of the necessary caps and flashings.

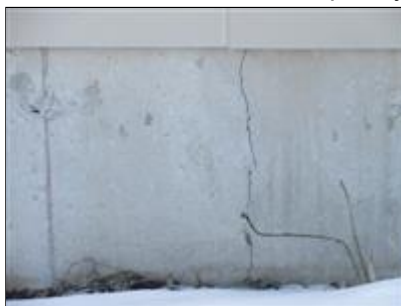
2.1 Picture 1

There is a very minor exterior foundation crack at the left side. This is quite typical and not a structural concern.

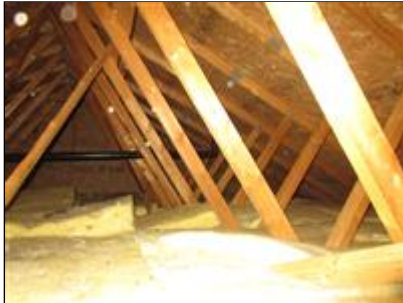
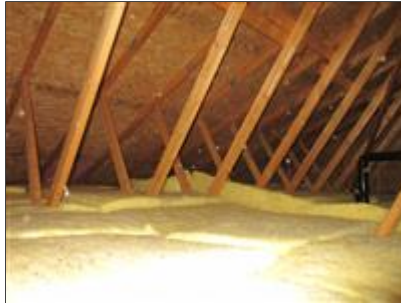
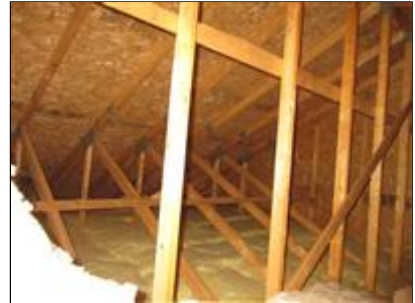
4.0 Picture 1

The attic contains fiberglass batt insulation. This insulation appears to be well placed and installed in more than adequate amounts.

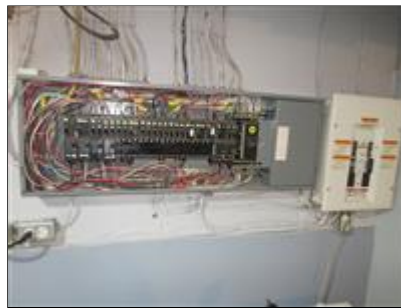
5.2 Picture 1

The main electrical panel was inspected and found to be installed properly and wired correctly. All of the proper sized breakers were present.

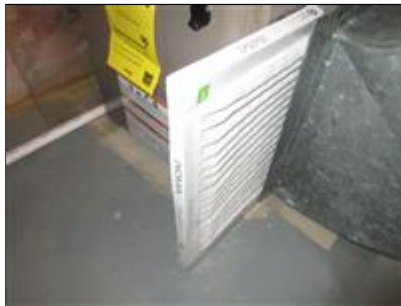
6.0 Picture 1

- (1) The furnace was tested and inspected and found to be installed properly and working well. All the necessary safety features were present.
- (2) The furnace filter should be changed on a regular basis.

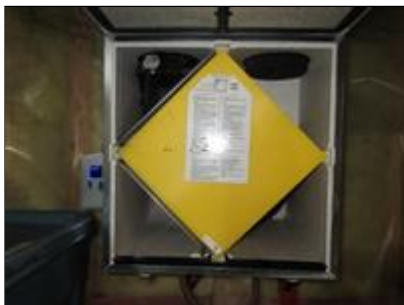
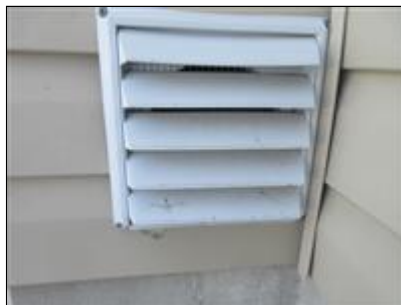
6.10 Picture 1

The heat recovery ventilator filters including the outside fresh air intake screen will require cleaning on a regular basis (see manufacturers recommendations).

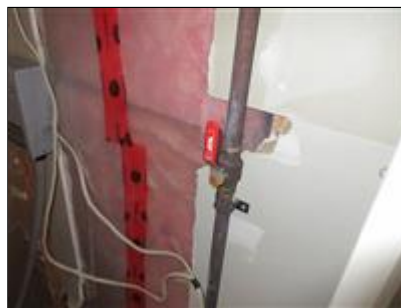
7.4 Picture 1

At pressure tank.

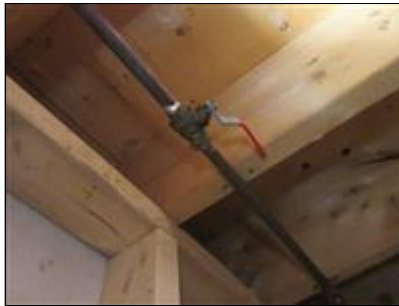
7.12 Picture 1

The outside taps should be shut off and drained before winter.

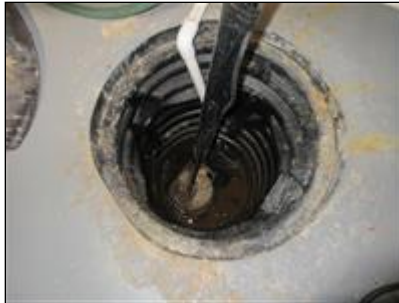
7.13 Picture 1

The sump pump should be tested on a regular basis to ensure its proper operation.

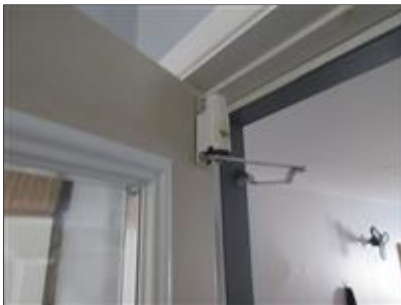
8.5 Picture 1

The self-closing device on the door from the garage to the house is not adjusted properly as it is not closing the door. If possible this should be adjusted to close the door to ensure proper gas proofing.
